Take Control & Save[®]

Residential energy efficiency pilot program

Johnston family pilot project - Clarence, Mo.

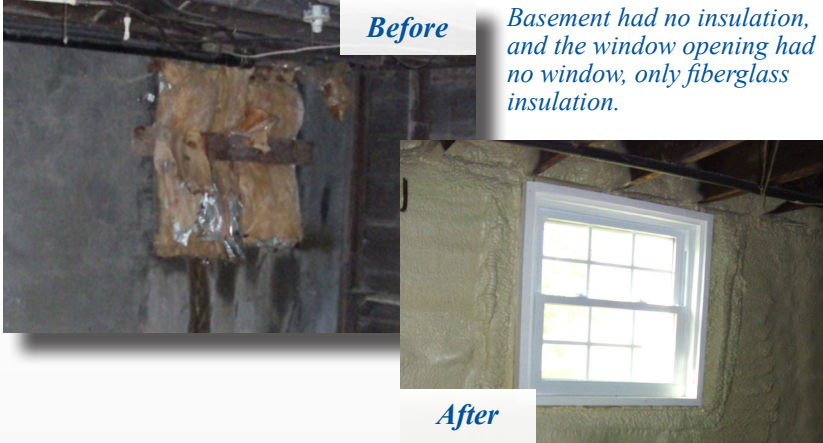
Photos of insulation and windows

1. Cellulose insulation added to all exterior walls and blown in the attic
2. Closed cell foam insulation added to all foundation walls, rim joist area and attic closet spaces
3. Weatherized doors and windows using **over eight cases of caulk!**
4. Replaced four basement windows
5. Front door replaced with Energy Star door
6. Insulated and sealed the duct work
7. Air-sealed the main attic access and fireplace
8. Replaced all lighting with compact fluorescent light (CFL) bulbs

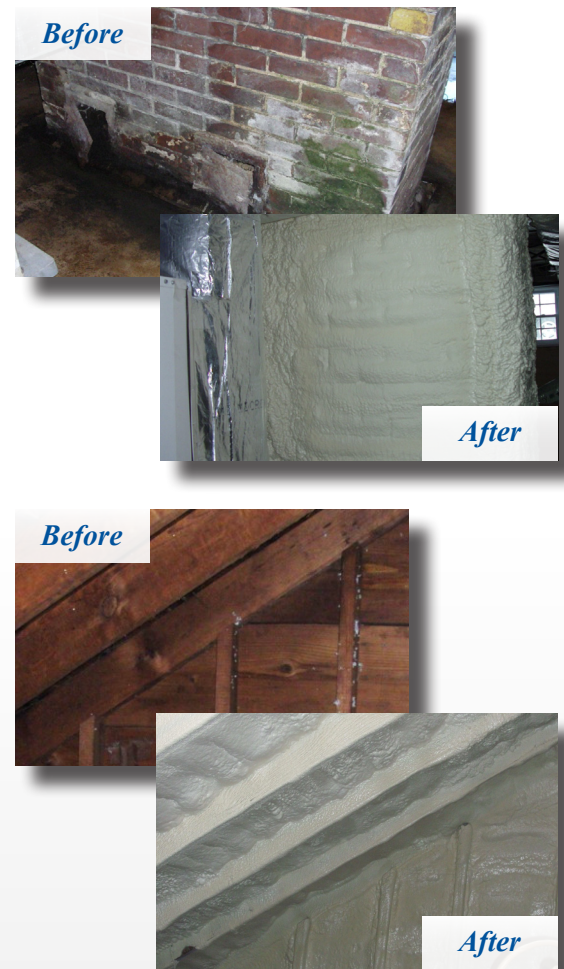
Photos of the spray foam insulation
